407 TRANSITWAY – WEST OF BRANT STREET TO WEST OF HURONTARIO STREET
MINISTRY OF TRANSPORTATION - CENTRAL REGION

HERITAGE IMPACT ASSESSMENT

3269-3271 DUNDAS STREET WEST

**HIGHWAY 407 TRANSITWAY TRANSIT PROJECT ASSESSMENT PROCESS
FROM WEST OF BRANT STREET TO WEST OF HURONTARIO STREET G.W.P. 16-20003**

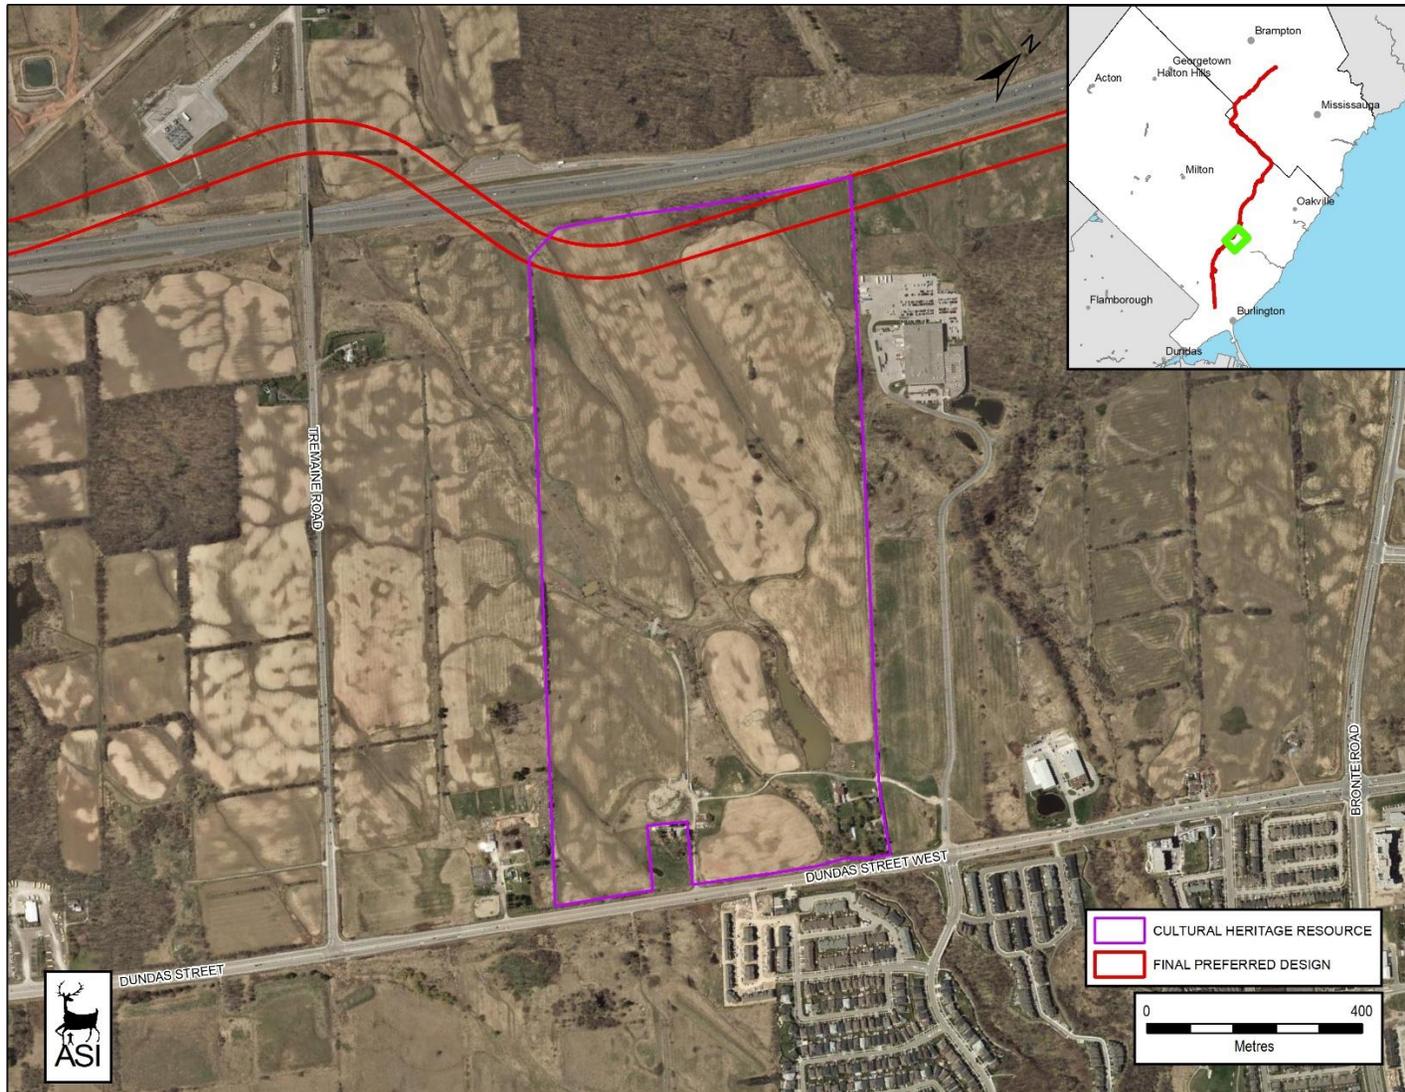
Figure 2: Aerial photo of the subject property at 3269-3271 Dundas Street West and proposed design of 407 Transitway (Google Earth Imagery)

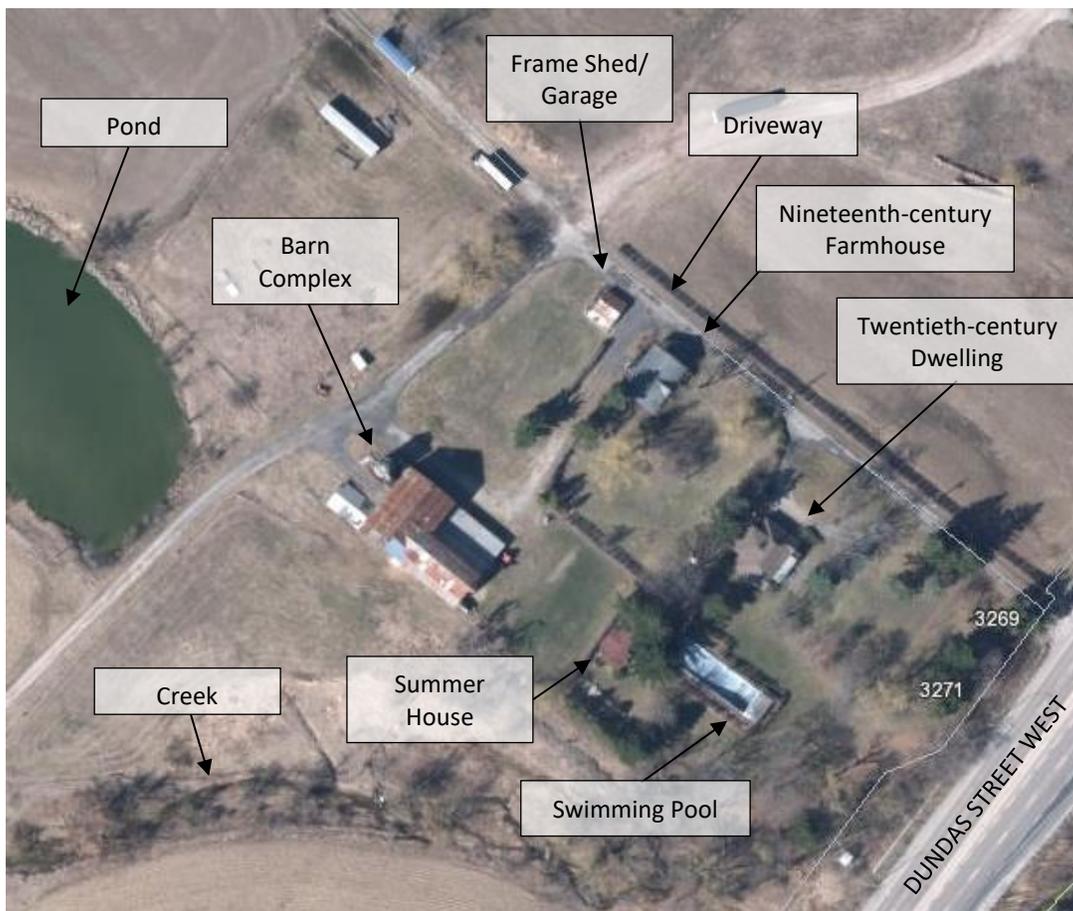
Plate 1: Plan view of the features on the subject property (Town of Oakville).

The location of all the built and landscape features on the property is determined largely from aerial and satellite photography, as well as photography from 2010 and 2014, as visibility of all features from the right of way was limited due to the density of surrounding vegetation at the time of field inspection (3 March 2020).

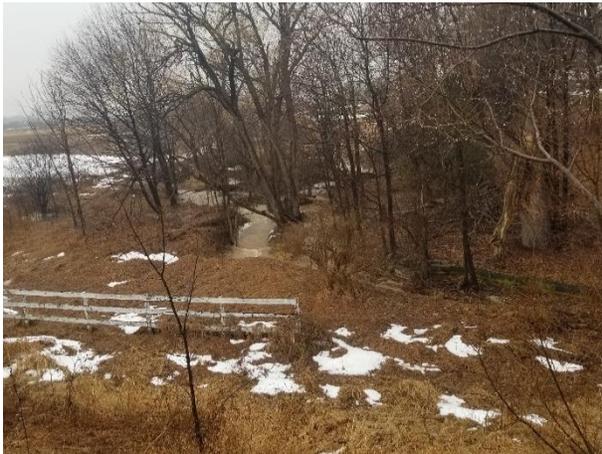
Plate 8: Looking north from Dundas Street West showing creek located west of farmstead (2020).

Landscape features on the property include a creek, a pond, mature trees, crop fields, and slightly undulating topography. The creek is located to the west of the built features on the property and runs southeast towards Dundas Street West creating a small valley in the topography (Plate 8). Stone shoring has been added to the banks of the creek and a small utility structure has also been constructed in the land between the creek and Dundas Street West (Plate 9). The pond, which was added to the property in the twentieth century, is located northeast of the barn complex (Plate 10). Mature trees and hedges grow amongst the built features that comprise the farmstead. Surrounding the farmstead are crop fields, which extend to the northern limits of the property (Plate 11).

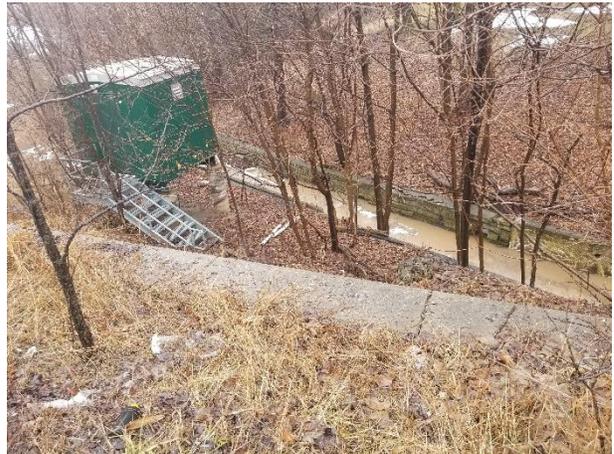
Plate 9: Stone shoring and utility structure adjacent to the creek (2020).

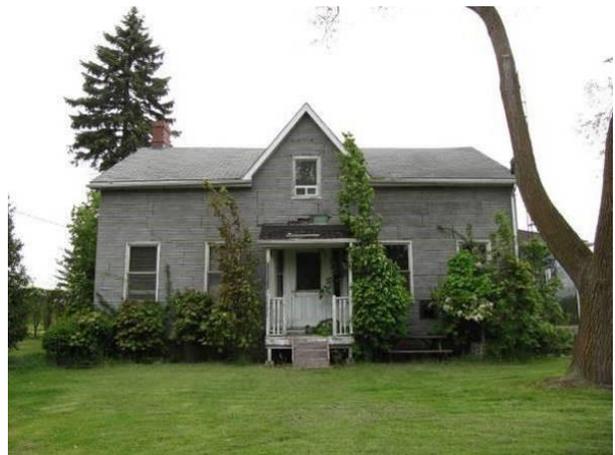
Plate 13: Primary (south) elevation of nineteenth-century farmhouse, looking north (ASI 2010).

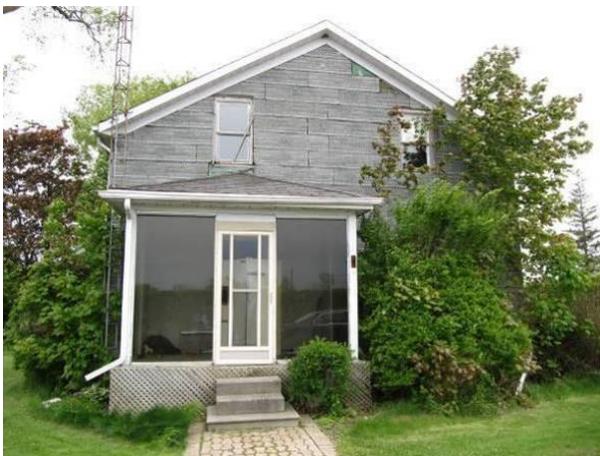
Plate 14: East elevation of the farmhouse, looking west (ASI 2010).

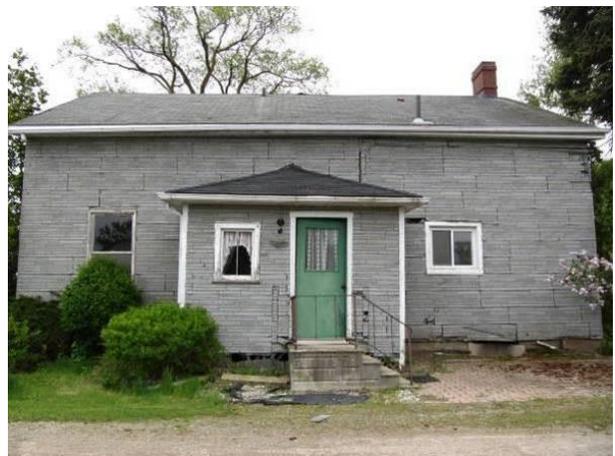
Plate 15: Rear (north) elevation of the farmhouse, looking south (ASI 2010).

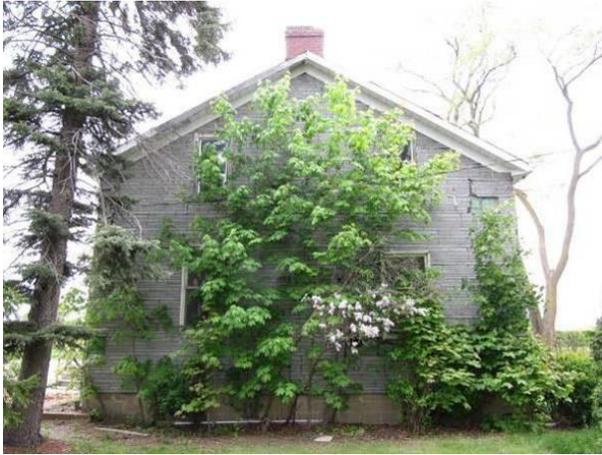
Plate 16: West elevation of the farmhouse, looking east (ASI 2010).

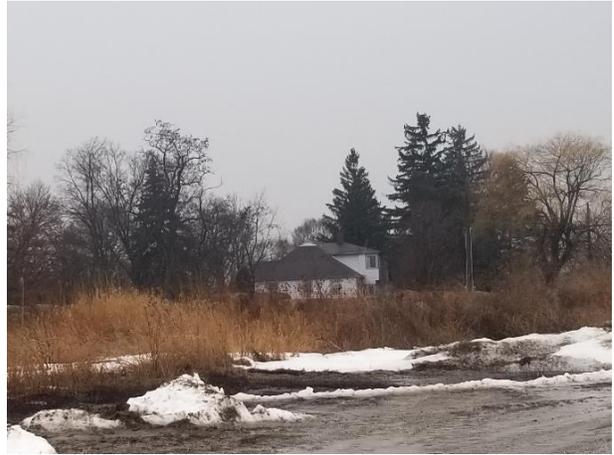
Plate 17: East elevation of twentieth-century dwelling, looking west (2020).

The dwelling added to the property in the twentieth century is a one-and-a-half storey vernacular residence (Plate 17 and Plate 18). The building is likely frame construction and the form is generally rectangular with narrow rectangular extensions on the north and south elevations, possibly added after the building was initially constructed. The structure has a cross-hipped roof, with the eaves of the overall rectangular structure extending to the first storey. A central chimney is visible in the roofline. From what is discernible in earlier photography and from the public right of way, there is no clear pattern present in the existing window openings. An entrance is located on the rear (north) addition, and there is likely one on the primary (south) elevation that faces Dundas Street West. The entire structure is clad with vinyl siding.

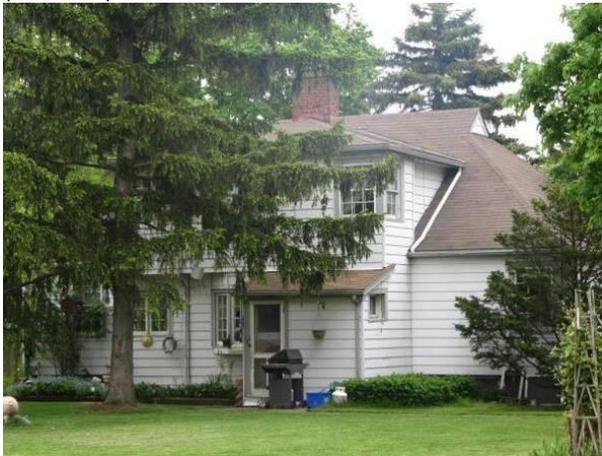
Plate 18: North elevation of the twentieth-century dwelling, looking southwest (ASI 2010).

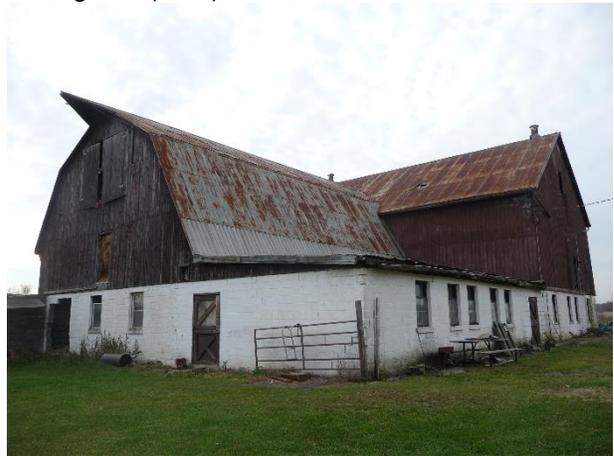
Plate 19: Barn complex showing gambrel addition (left), one-storey flat roof addition (centre) and heavy timber bank barn (right/rear) (Town of Oakville 2014).

The existing barn complex consists of three distinct sections: the original heavy timber bank barn; a gambrel barn addition; and a subsequent one-storey flat roof shed addition (Plate 19 and Plate 20). The timber bank barn is dated to the turn of the century and consists of a two-and-a-half storey heavy timber post and beam frame and a gable roof. The original stone foundation for the bank barn has been replaced with concrete block. There are several openings in this concrete block foundation. The primary access for large agricultural implements is provided on the north elevation, facilitated by an earthen ramp to the second story.

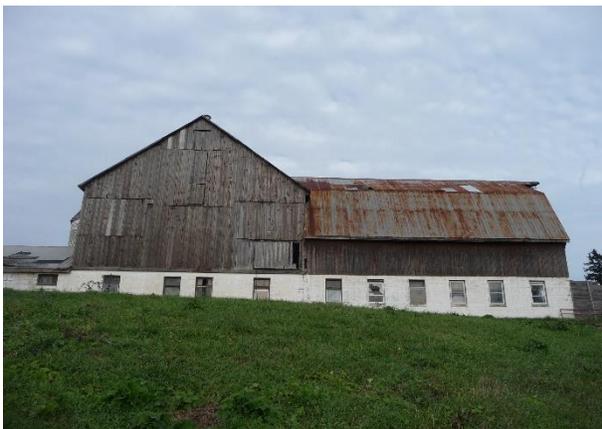
Plate 20: West elevation of the barn complex showing bank barn (left) and gambrel addition (right) (Town of Oakville 2014).

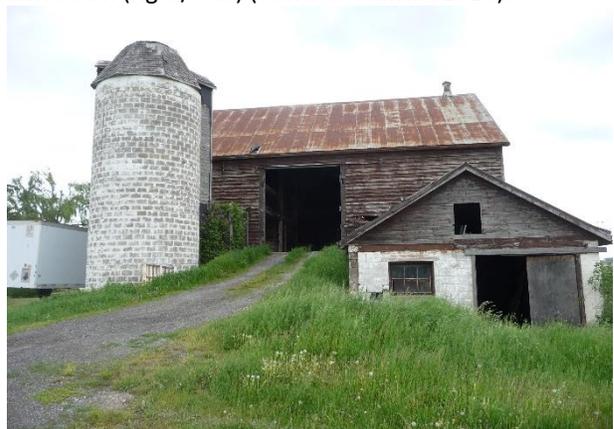
Plate 21: North elevation of barn complex showing silo (left) bank barn (centre) and smaller gable roof shed addition (right) (Town of Oakville 2014).

The gambrel barn and shed additions date to the mid-twentieth century and both have been constructed on a concrete foundation. The structure of the gambrel barn addition is formed using a large wood gambrel truss system that shapes the wall and roof. Both the original bank barn and the gambrel addition have standing seam metal roofing. The concrete block foundation of the flat roof addition extends to also form the walls of the one-storey structure. The flat roof of this addition supports a wooden roof deck. A smaller gable roof shed structure was added to the north elevation of the barn, and a concrete block silo was built immediately northeast of the barn (Plate 21).

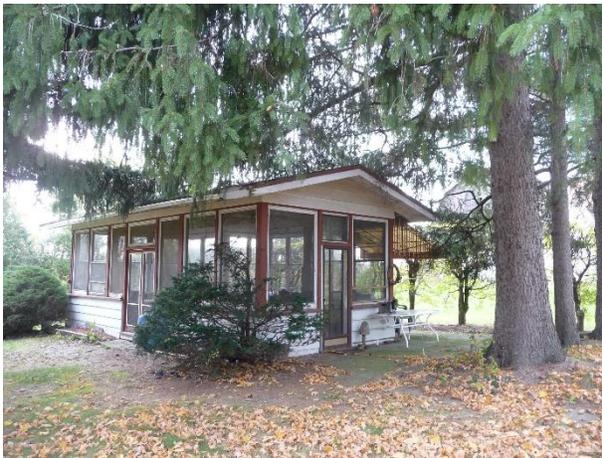
Plate 22: Summer house looking northwest (Town of Oakville 2014).

The remaining structures on the property are secondary and associated with the late twentieth and early twenty-first century occupation of the property. The summer house is located west of the twentieth-century dwelling. The wood frame structure is subtly T-shaped, with open walls covered with mesh screen and a cross-gable roof (Plate 22). The pool is a rectangular concrete feature that contains a low concrete perimeter wall, concrete diving platform, and wooden deck on the west side of the pool. The pool itself slopes below grade from north to south (Plate 23). The frame shed is a basic frame structure with corrugated metal siding and sheet metal roofing on the saltbox roofline. A large double opening is located on the south elevation, providing access to vehicles or smaller agricultural implements (Plate 24).

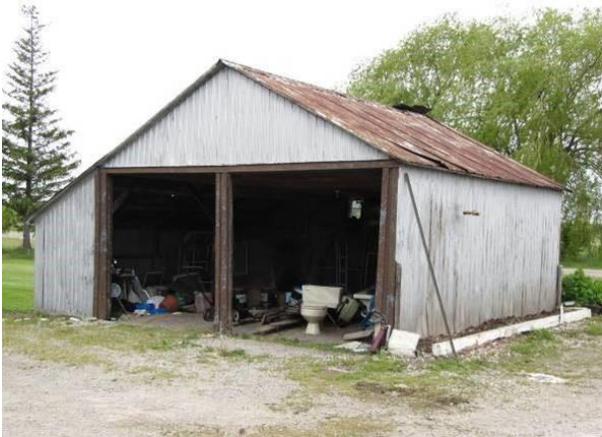
Plate 24: Frame shed/garage looking northwest from the driveway (ASI 2010).

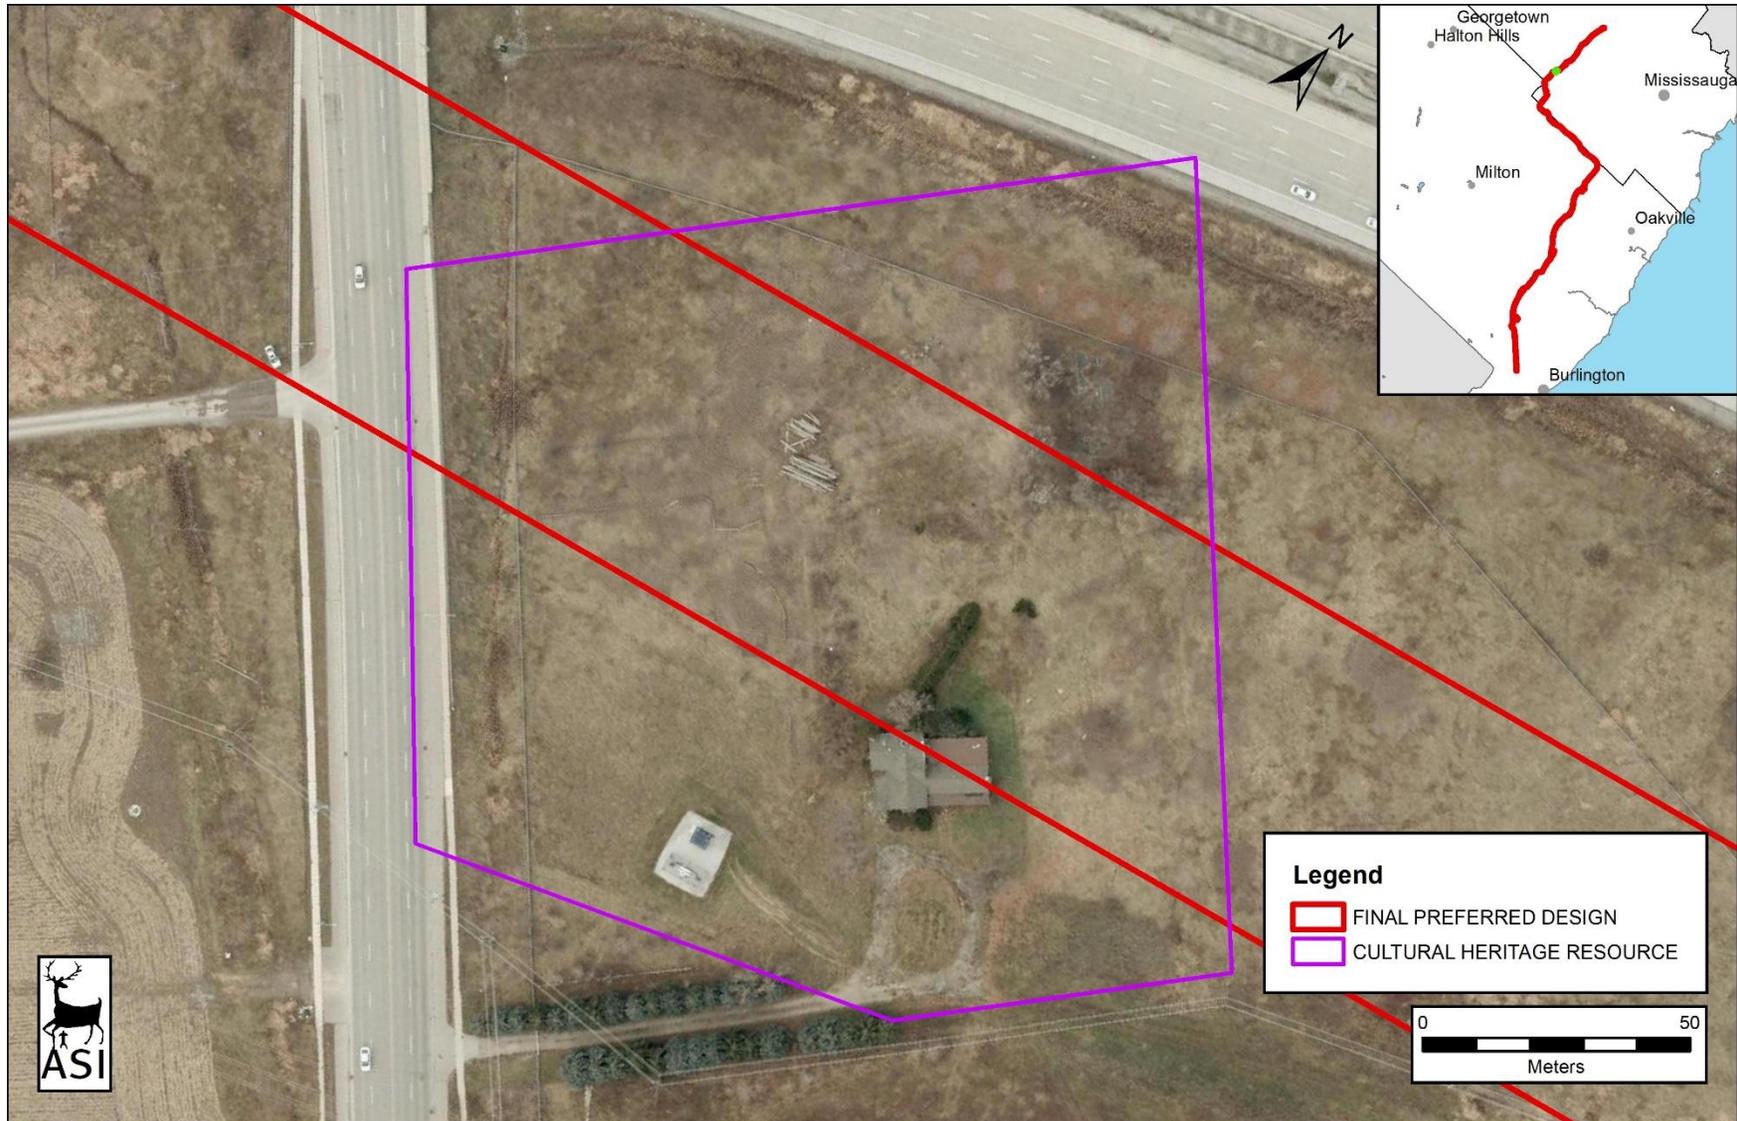
Figure 2: Aerial photo of the subject property at 7655 Heritage Road and proposed design of 407 Transitway (Google Earth Imagery)

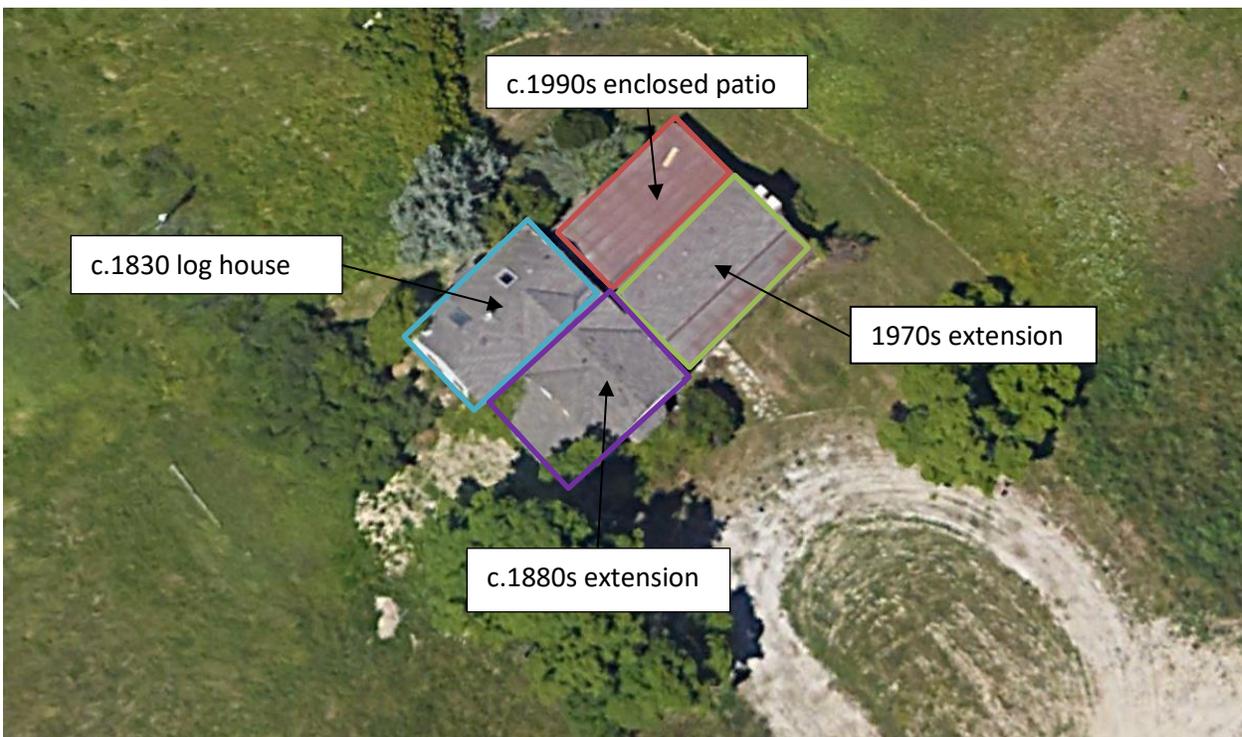
Plate 5: Plan view (Source: Google Earth)

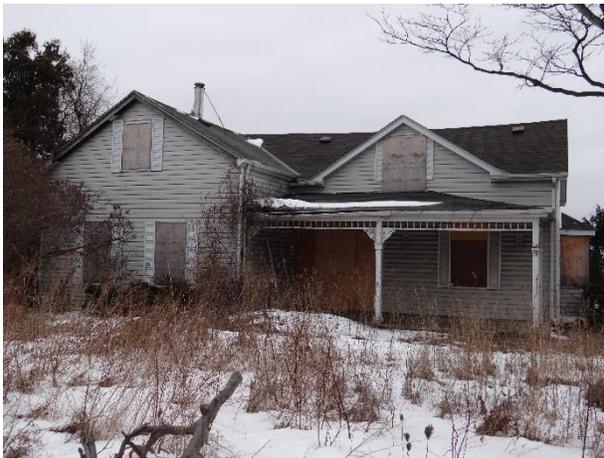
Plate 6: West elevation, log house portion is on the left

The west elevation features a covered front porch with decorative posts and trim, a low-profile gabled dormer over the porch, and the front entryway into the house. Decorative shutters are located at each of the windows. The south elevation of the c.1880's frame house features two windows on the second floor, and a bay window on the main floor. The north elevation features a central entrance with covered portico, and windows to either side. Sky lights are visible in the roof on this elevation. The rear or east elevation of this house is obscured by the addition of an enclosed back deck/porch area, and the 1970's extension. However, two dormer windows are visible in the roof line.

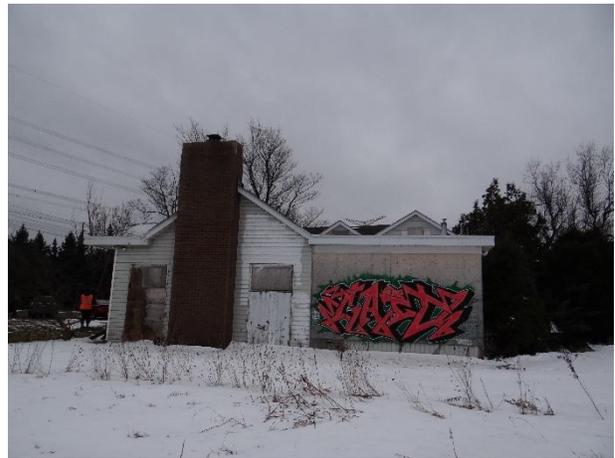
Plate 7: East elevation

The c.1970's rear addition to the east elevation of the original house sits on concrete foundations. A former exterior porch area with concrete flooring, now enclosed, is located to the north of the rear addition. The north elevation is largely obscured by vegetation and the enclosed porch area, which is also boarded up. The east elevation features a large brick chimney and two windows, and the south elevation features a central entrance and several windows.

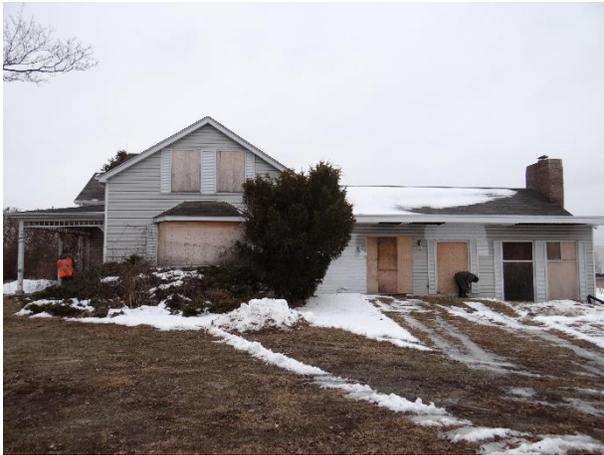
Plate 8: South elevation

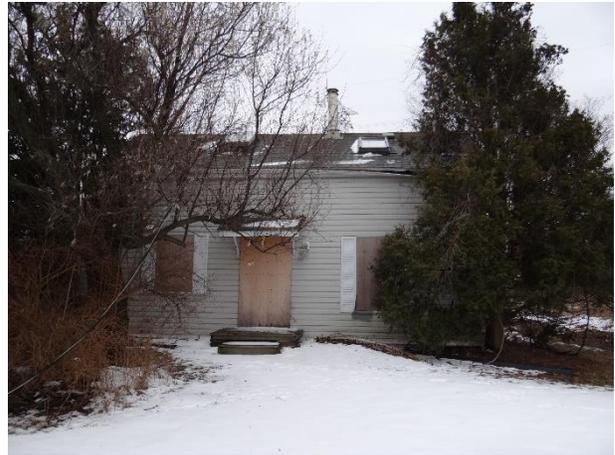
Plate 9: North elevation (log house portion)

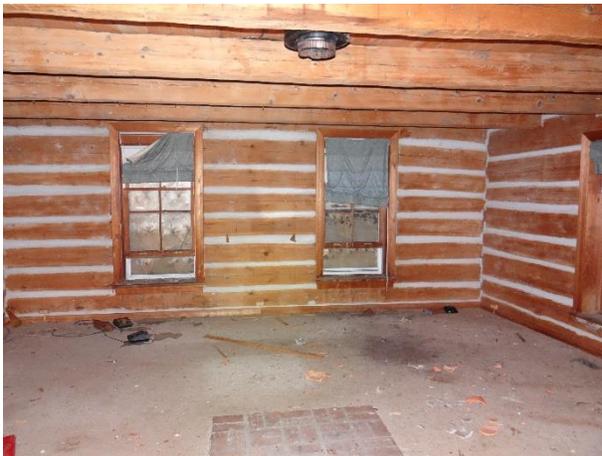
Plate 10: View of log house main floor, looking west

The log house portion sits on stone foundations, and features a basement, main floor and second floor. The rectangular footprint of the log house is approximately 10 metres by 7 metres. The main floor (Plate 10 - Plate 13) is one large room with a built-in kitchen, two-over-two pane sash windows on the north, west and east walls, and a set of narrow stairs leading to the second floor at the southeast corner of the structure. The exterior door on the north elevation is modern, along with all window and door trim. The flooring has been removed, with areas of tile remaining. The hewn joists above are visible, and the large hewn flat-sided logs forming the walls of the log cabin are also visible with mortar chinking applied. A former doorway on the south wall has been converted into a bookcase, and another doorway on the south wall towards the east elevation leads to the c.1880's structure.

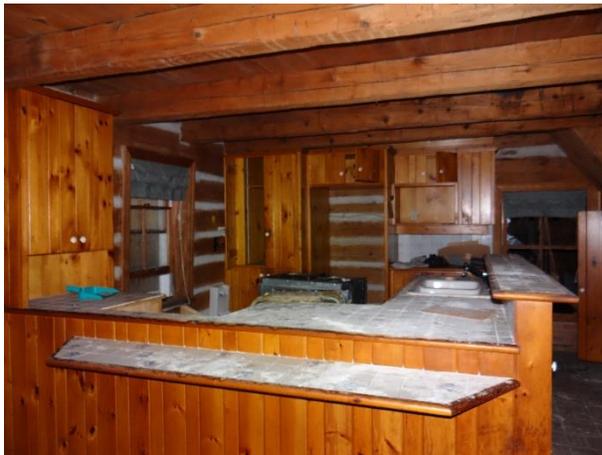
Plate 11: View of log house main floor looking north, note the flat-sided logs and mortar chinking

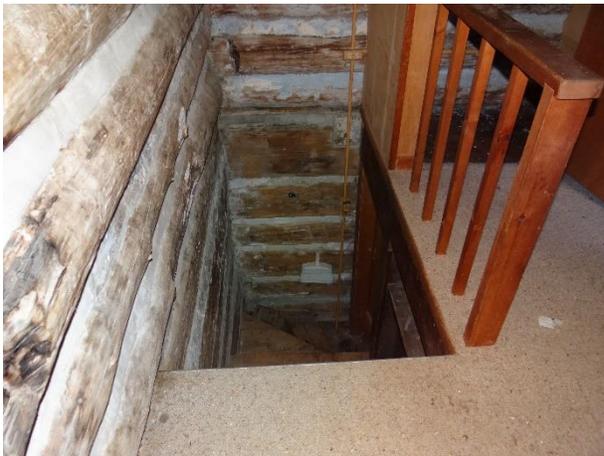
Plate 14: View looking down stairwell, looking south, note the rounded logs

The curved stairwell leading to the second floor (Plate 14 - Plate 17) of the log house portion leads into an open hallway which provides access to two bedrooms, two storage areas, and features one window on the east wall. A large bedroom is located at the western portion of the second floor, and a second smaller room is in the middle along the north elevation. A closet is located at the northeast corner, and additional storage is found on the south wall of the hallway. Skylights are in each bedroom, and windows on the east and west elevations are two-over-two pane sash windows, similar to those on the main floor. All doors and trim are modern, as well the railing in the hallway, and it is carpeted throughout. The log walls are rounded, rather than flat-sided. The windows on the east and west elevations are located above the top of the log walls, where gable dormers have been incorporated into the structure and to allow for more living space on the second floor.

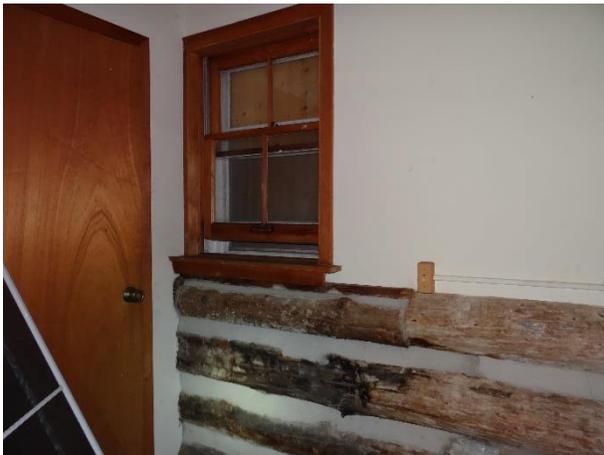
Plate 16: Detail of the logs and window on east wall of the hallway, log house second floor

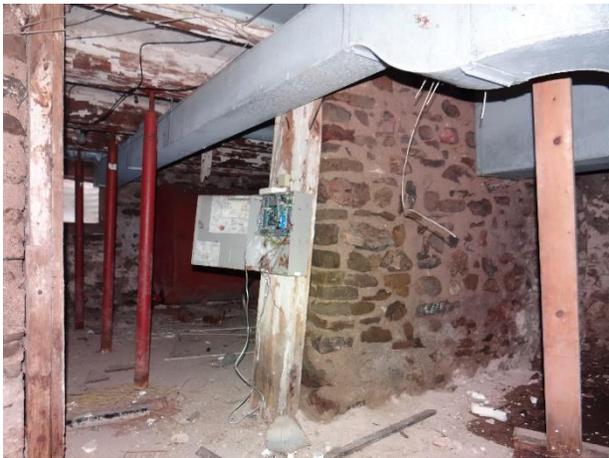
Plate 18: View of the basement looking west.

The log house portion of the house sits on fieldstone foundations (Plate 18 - Plate 19). The basement is divided into an east and west section, with exterior access to the basement located at the rear of the house, on the east elevation. A former trap door from the main floor is also located at the end of the basement. Large hewn floor joists are overhead supporting the wooden base flooring above.

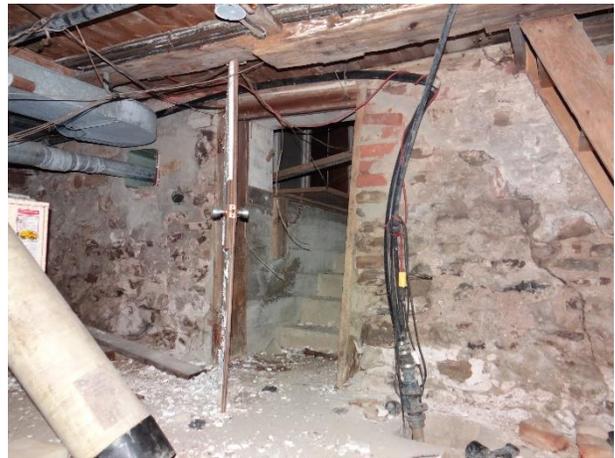
Plate 19: View of the basement looking east.

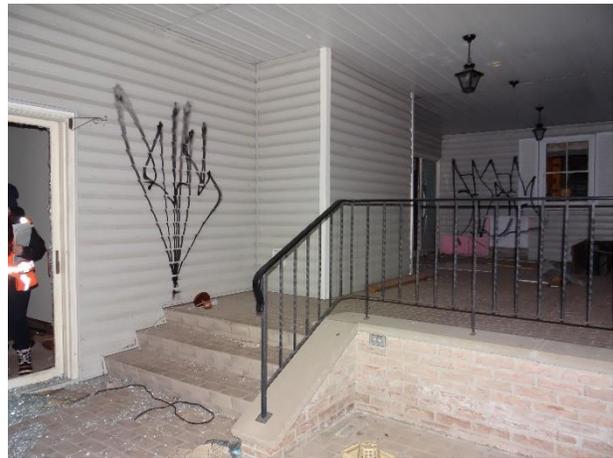
Plate 27: Enclosed exterior patio area at northeast of the house

The 1970's extension is located on the east elevation of the c.1880's portion of the house (Plate 24 - Plate 27). A long hallway along the north wall provides access to an enclosed sunroom, formerly an outdoor patio, as well as access to a bathroom, kitchen, and living area located along the south and east parts of this extension. A fireplace is located on the east wall in the living room. Flooring was noted as either carpet or tile, and doors, windows and trim were noted as modern. Two sets of sliding patio doors are located on the north elevation, and one sliding door is on the south elevation. While generally boarded up, it would appear that the openings in the living room are French doors with casement windows above.

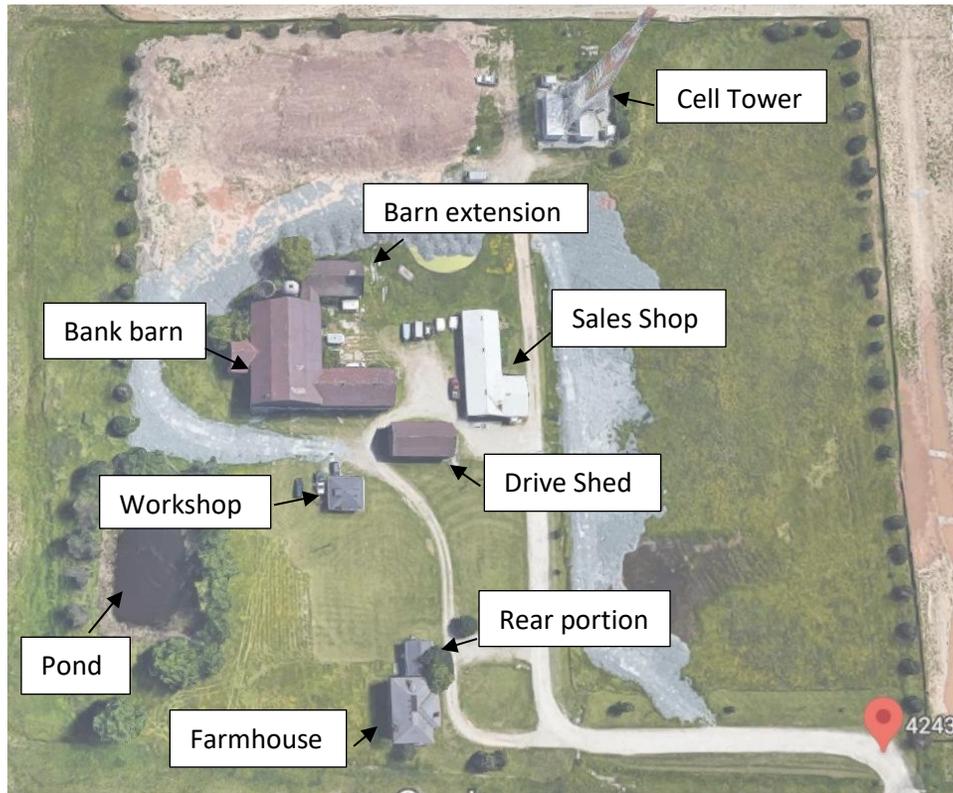
Plate 1: Plan view of the features on the subject property (Google Maps)

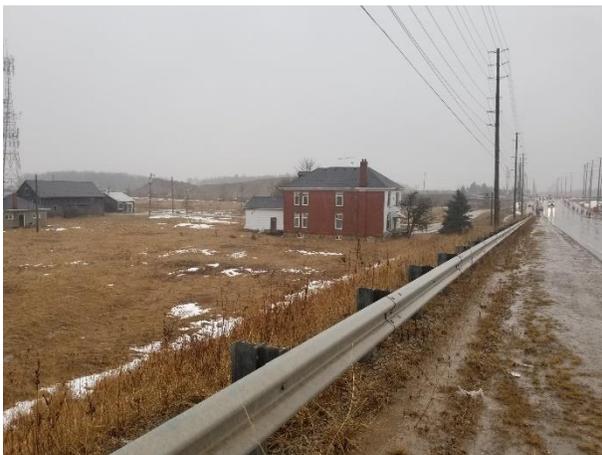
Plate 8: Embankment supporting Sixth Line, facing south.

parallel to Sixth Line since the creation of Highway 407 in the mid-1990s), an embankment (which has supported Sixth Line since the creation of the bridge over Highway 407 in the mid-1990s), the circulation routes between the house and barns, a small pond surrounded by trees, large open spaces, and vegetation and trees around the house, barns, and north and south edges of the property (Plate 5 to Plate 9).

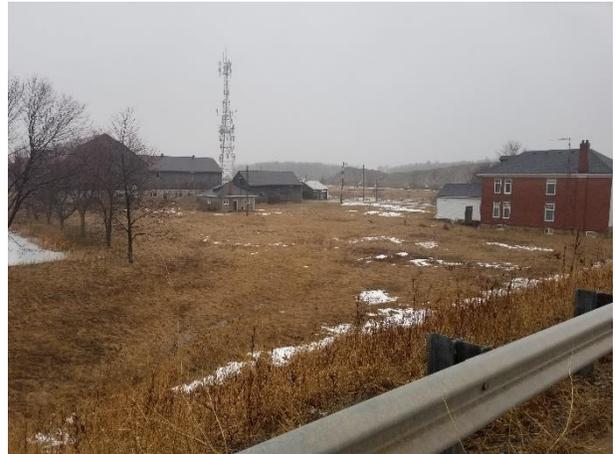
Plate 11: House, barns, outbuildings, and cell tower, facing southeast.

- A single-storey barn that includes the sales shop/store front and cold storage area located south of the bank barn. It features a metal roof and aluminum siding (Plate 23).
- The radio/cell tower, made of metal, located on the east side, near the property boundary (Plate 11).

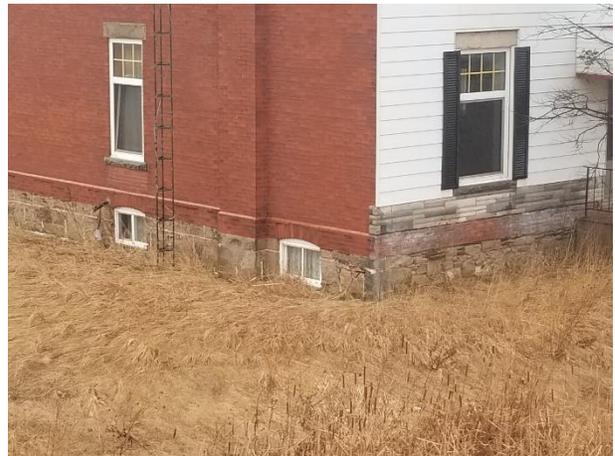
Plate 15: Stone foundation, north elevation.

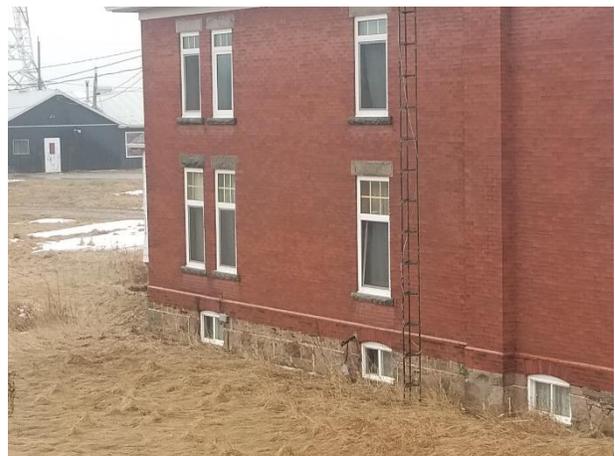
Plate 19: Symmetrical windows with lintels and sills, north elevation.

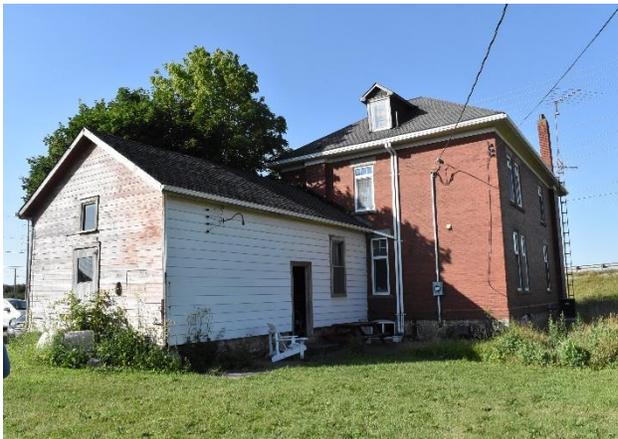
Plate 20: Single-storey, wooden frame structure at rear of house, facing west (Town of Oakville, 2018).

The residence is a two-storey red brick Edwardian Classical farmhouse with horizontal aluminum siding and stone veneer over the front façade. The aluminum siding and stone cladding were added to the front façade at an unknown date. The former front entrance is on a small raised front porch, though it appears in a state of disuse with the awning over the porch falling away from the vinyl cladding (Plate 12). That entrance faces west and sits approximately 15 metres from Sixth Line (Plate 12 and Plate 13). The house is rectangular, with a bay extension on the south side (Plate 14). Other features include two brick chimneys on the north and south sides, a hipped roof, and a single-gabled dormer on the rear façade. The residence sits on a stone foundation, and lower-level windows provide light into the basement (Plate 15). The current main entrance appears to be on the south side, east of the bay extension. A small concrete staircase rises to a small landing, with access to sliding doors into the main brick house as well as to a door to the rear portion (Plate 16). The house features decorative brickwork on the west side of the south façade and brick voussoirs over the basement windows (Plate 17). Another key feature is the date stone, noting the 1898 construction date (Plate 18). The windows, which are all modern replacements of the originals, are encased by large stone sills and lintels and are symmetrical on the upper and lower storeys except for one spot on the lower level of the south façade (Plate 19). Attached to the east end of the residence is a rectangular, single-storey, wooden frame structure, sitting on stone foundations (Plate 20). Horizontal vinyl siding, affixed at an unknown date, has been added to its north and south sides. This rear extension may be the original frame house built by Michael Biggar soon after purchasing the property.

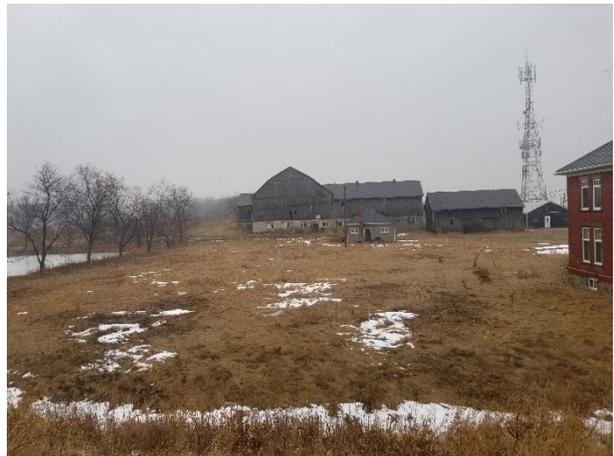
Plate 21: Barns, drive shed, workshop, and cell tower behind the house, facing east.

The gambrel bank barn with a gabled extension is the largest structure on the subject property (Plate 21) Located near the northeast corner of the subject property, it is L-shaped and features a rubblestone foundation and vertical board-and-batten cladding. The bank and main entrance are on the north side. There are large windows and openings in the barn basement, with decorative arched brick voussoirs above them (Plate 22). The remnants of two silos are adjacent to the barn on the east side. An addition/extension to the main barn is a smaller barn to the east (Plate 24).

- A single-storey workshop (former milk house), located between the farmhouse and bank barn. It is square in shape and made of concrete blocks. It features a hipped roof, chimney, small inset windows, a door on the west side, and large garage door opening on the east side (Plate 21).

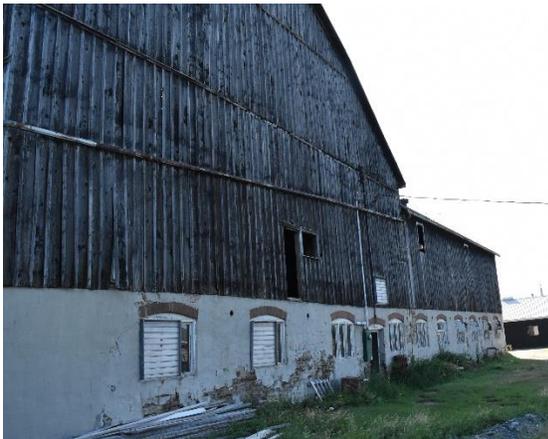
Plate 22: Decorative brickwork over barn windows, facing southeast (Town of Oakville, 2018).

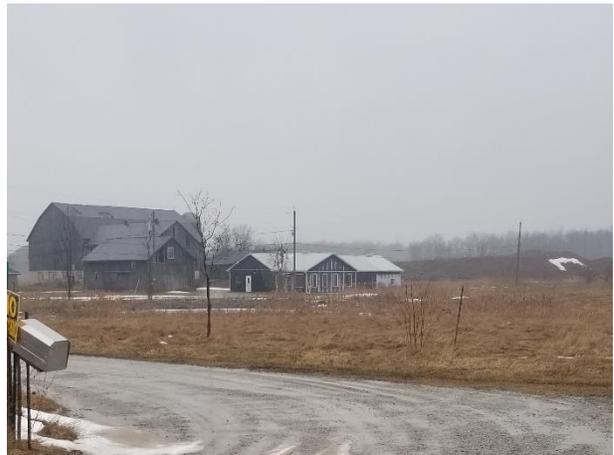
Plate 23: Barn, driveshed, and sales shop/storage facility, facing northeast.

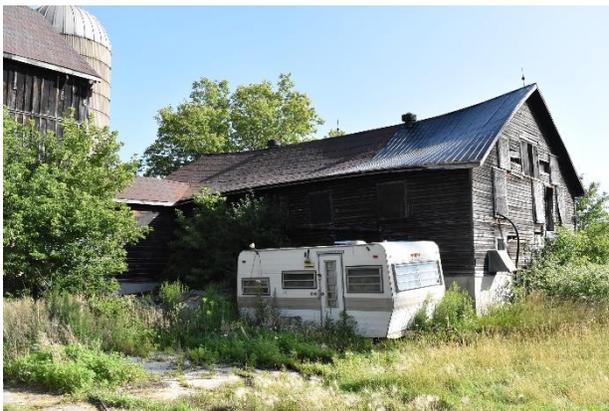
Plate 24: Barn extension and silo, facing northeast (Town of Oakville, 2018).

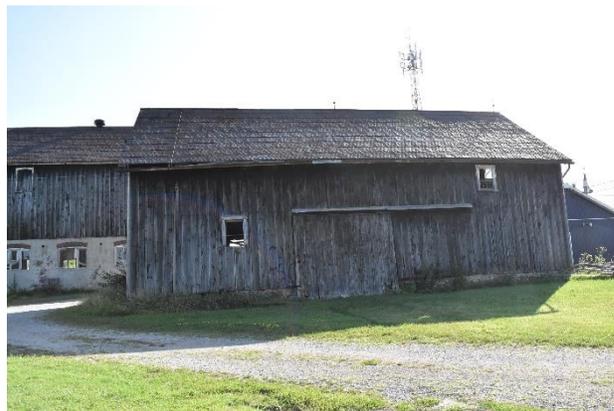
Plate 25: Driveshed, facing east (Town of Oakville, 2018).

A one-and-a-half-storey frame-constructed driveshed, built in the vernacular style, is also on the subject property, southwest of the bank barn. The driveshed has vertical board-and-batten wood cladding and large wood sliding doors on the lower level. It rests on a stone foundation, is rectangular in shape, and features a metal gabled roof with window openings in the end gables (Plate 25).

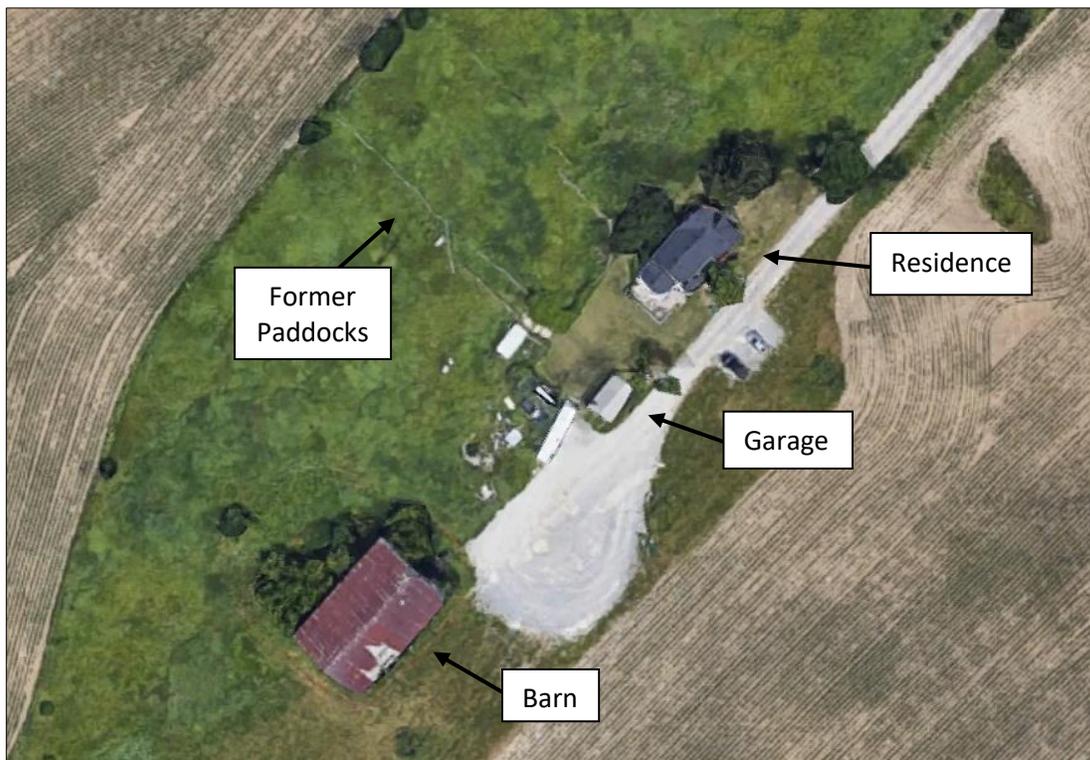
Plate 7: Plan view of the buildings located on the property (Source: Google Satellite)

The subject property is currently occupied by tenants and generally maintains its character as an agricultural property. The residence, barn, and other outbuildings are all located at the end of a long driveway (Plate 1, Plate 2 and Plate 7). Surrounding the buildings is a buffer of grassy lawn, with few mature trees located nearby the residence. Former paddocks are visible in overgrown grass in an area to the north of the residence and an additional area of overgrown grass extends west from the barn (Plate 3 and Plate 4). A hydro corridor runs through the property south of the residence and outbuildings (Plate 5). Farm fields are located beyond the grassed area surrounding the buildings and extend to the south and west limits of the property and also meet Highway 407 which runs through the northern portion of the property (Plate 6). The remaining part of the parcel located to the north of the highway contains a small reservoir.

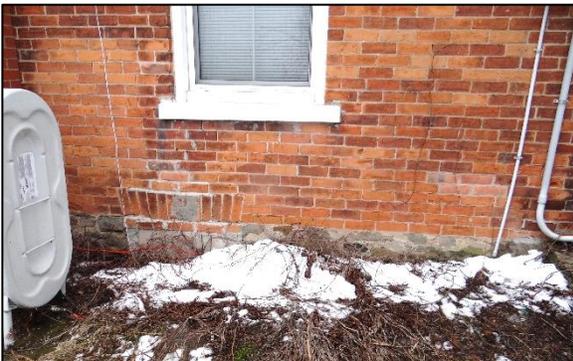
Plate 12: Stone foundation of original residence and basement window (in-filled)

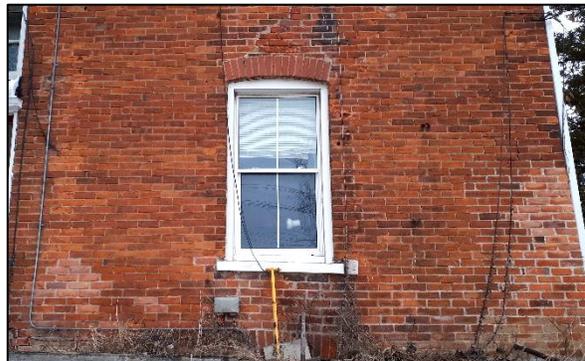
Plate 13: Detail of existing condition of exterior bricks and windows

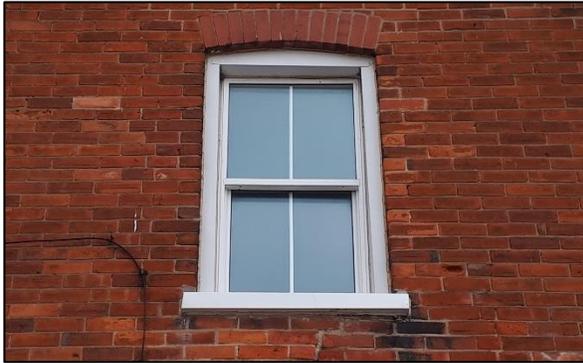
Plate 14: Detail of vinyl window replacement and (likely) vinyl or aluminum capped frame and sill. Brick deterioration is also observable

Vinyl double-hung windows have replaced all the original windows throughout the residence; however, the openings have all been maintained. All frames and sills have either been replaced or, more likely, covered over with vinyl or aluminium (Plate 14 and Plate 15). The segmental arch lintels above a majority of the windows, which are constructed using a slightly different brick from the red brick cladding the exterior, may have been reconstructed or replaced. The main entrance, located on the primary (east) elevation appears to retain its original door, and transom opening above (though the window has likely been replaced) (Plate 16). The door of the secondary entrance located on the south elevation is possibly original or dates from the early twentieth century, though the threshold and surround have been altered and an additional storm door has been added to the opening (Plate 17). Vinyl siding has been added to the fascia and soffits of the original structure, and a replacement decorative gingerbread trim has been installed on the centred gable on the primary elevation (Plate 18). The existing uncovered front porch as well as the side veranda on the south elevation have both replaced those originally built. On the north elevation a bricked-in doorway and concrete slab located along the foundation point to the likely location of a former veranda which is no longer extant (Plate 19). The chimney, also located on the north elevation, has either been replaced or re-bricked. In addition to the bricked-in doorway, a small window opening has been cut into the north elevation.

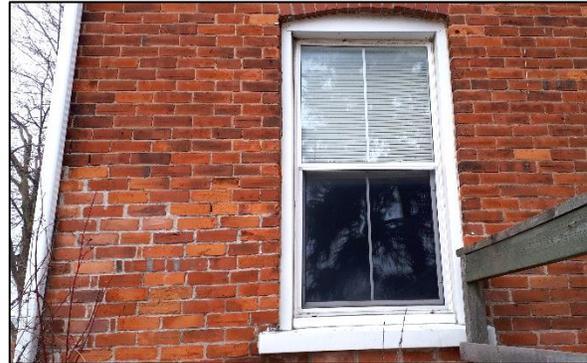
Plate 15: Detail of vinyl window replacement on primary (east) elevation and repointed and spalling brick (left)

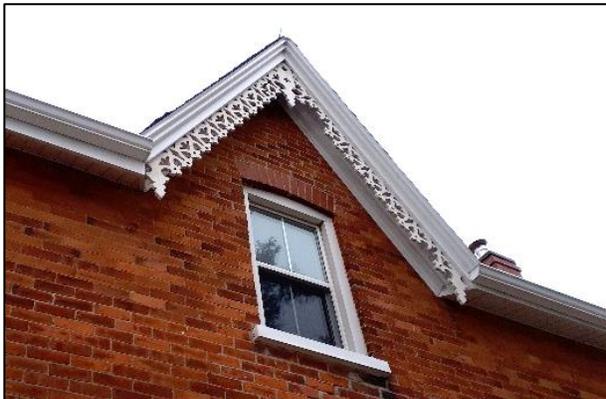
Plate 18: Detail of replacement gingerbread trim on east elevation and vinyl additions to fascia and soffits (applied throughout original residence)

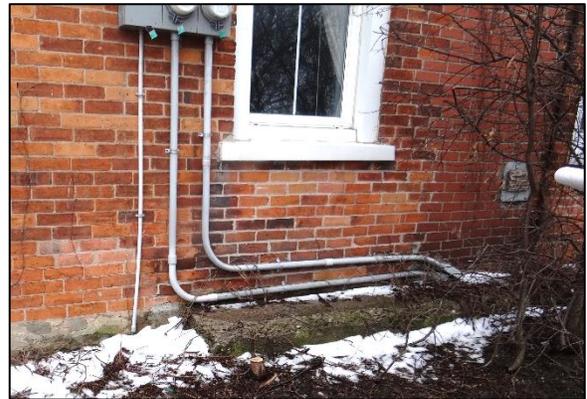
Plate 19: Detail of concrete feature along foundation and in-filled doorway (right), suggesting the location of a former veranda
