407 TRANSITWAY – WEST OF BRANT STREET TO WEST OF HURONTARIO STREET
MINISTRY OF TRANSPORTATION - CENTRAL REGION

HERITAGE IMPACT ASSESSMENT

3269-3271 DUNDAS STREET WEST

**HIGHWAY 407 TRANSITWAY TRANSIT PROJECT ASSESSMENT PROCESS
FROM WEST OF BRANT STREET TO WEST OF HURONTARIO STREET G.W.P. 16-20003**

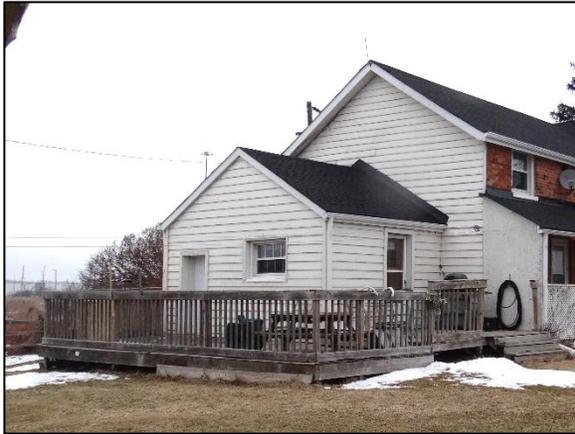
Plate 20: West elevation of original residence (right) and rear addition and porch (centre)

A small, one-storey addition is located on the rear (west) elevation (Plate 20). The addition has a gabled roof and is clad in vinyl siding. Vegetation and siding prevented observation of the foundation. An uncovered porch wraps around the south and west sides of the addition. Additional background documentation and more detailed historical mapping is required to determine when this addition was constructed.

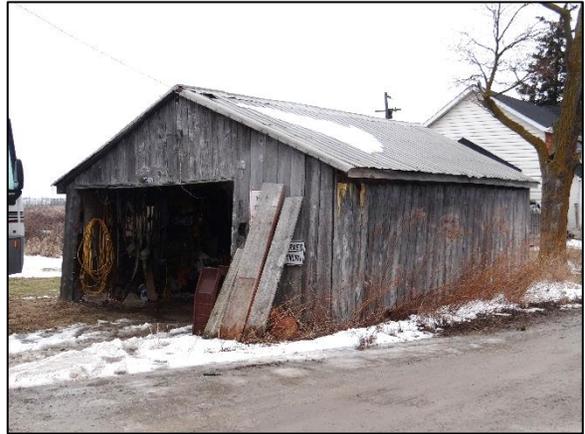
Plate 21: Single car garage

The property also contains a detached one-storey single-car garage, located west of the residence on the north side of the driveway (Plate 21). The structure is wood frame construction with a gable roof featuring standing seam metal roofing, and an opening on the west elevation. No foundation is visible, and the building appears to be structurally compromised. Further west from the garage and located at the terminus of the driveway is the barn (Plate 22 to Plate 25). The barn is dilapidated; however, the remaining material elements indicate that it was constructed with a stone foundation and a two-and-a-half-storey wooden structure. Overgrown grass and brush now surround a majority of the base of the structure, and a section of the roof has caved in, making the barn largely unusable/inaccessible. An earthen banked entrance to the second floor of the structure is located on the north elevation. The barn has a gabled roof with some standing seam metal roofing remaining on some portions.

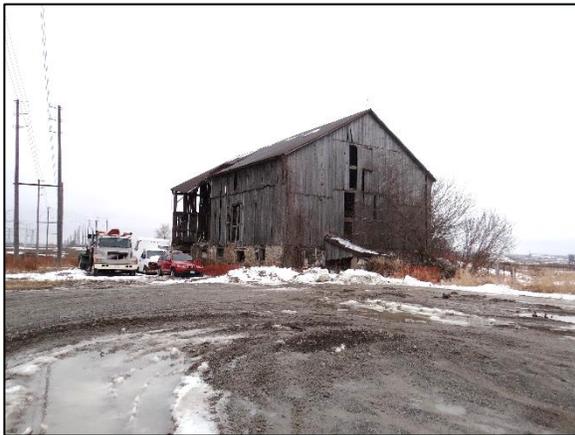
Plate 22: South (left) and east (right) elevations of the barn

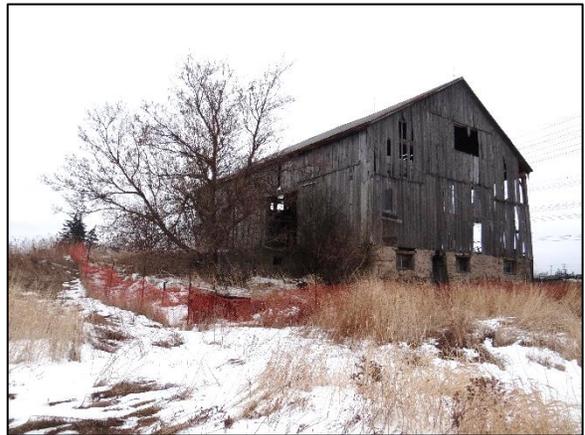
Plate 23: North (left) and west (right) elevations of the barn

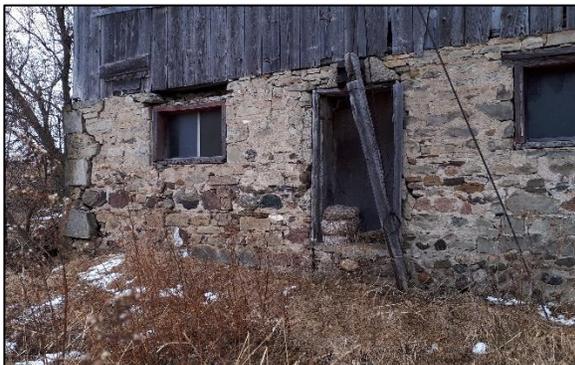
Plate 24: Detail of the barn's stone foundation

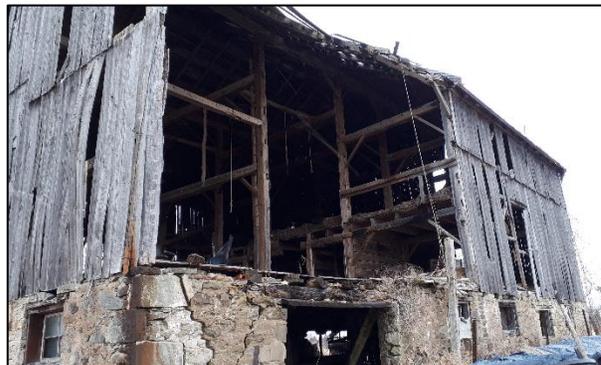
Plate 25: Interior view of the barn from exterior showing frame construction

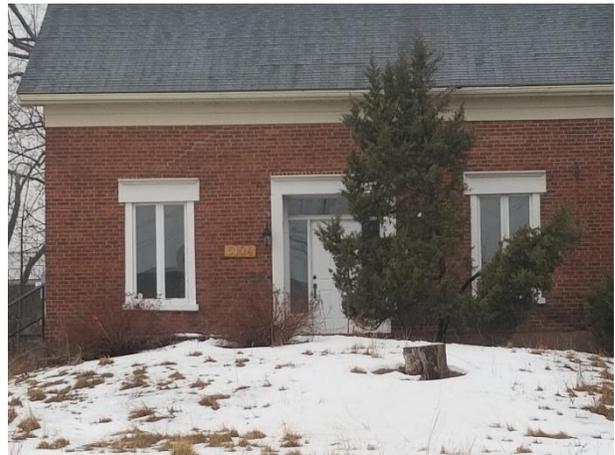
Plate 9: Detail of front elevation, replaced windows, and vinyl fascia under the eaves (March 2020)

The front façade (northeastern elevation) (Plate 9) features a central doorway with sidelights and a transom. There are windows symmetrically flanking the entrance. The southeastern elevation features two windows on the main floor and two on the second storey. The northwest elevation also has two windows on each storey and remnants of a former chimney are visible on the brick. The windows and the front door all appear to have been replaced, however brick voussoir lintels are still visible beneath the replacement trim in some cases. The house features overhanging eaves and a vinyl fascia beneath the eaves. The brick cladding is in a common bond pattern with a header course every sixth course.

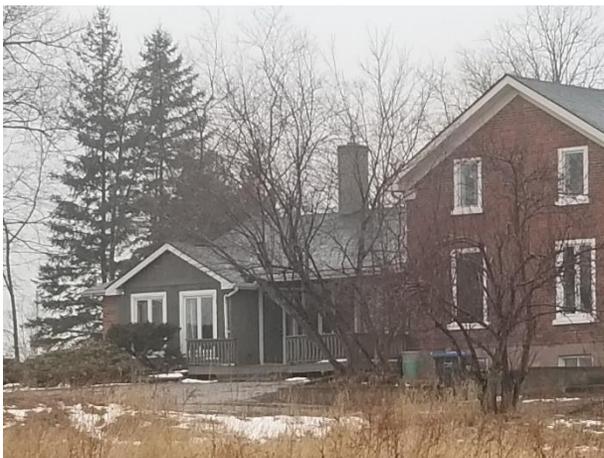
Plate 10: Detail of the board and batten rear addition and some of the brick addition (March 2020)

The addition, southwest of the original structure (Plate 10) is clad in painted wood board and batten and another addition was attached to the first addition and is clad in light red brick. The additions both have gable roofs, square windows, and doors.

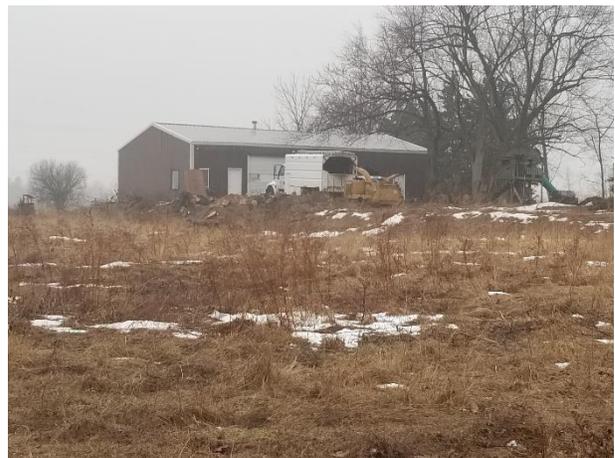
Plate 11: View of the garage, southwest of the house (March 2020)

A large garage is located to the southwest of the house (Plate 11). The garage features a utilitarian design with a rectangular footprint and is clad in aluminum siding. The garage has a gable roof, two garage doors, and simple windows and doors.
